DEPARTMENT OF TRANSPORTATION**DIVISION OF ENGINEERING SERVICES**

Contract #: 04-0120F4Cty: SF/ALA Rte: 80 PM: 13.2/13.9File #: 69.28**WELDING INSPECTION REPORT****Resident Engineer:**Siegenthaler, Peter**Address:** 333 Burma Road**City:** Oakland, CA 94607**Report No:** WIR-017850**Date Inspected:** 04-Oct-2010**Project Name:** SAS Superstructure**OSM Arrival Time:** 700**Prime Contractor:** American Bridge/Fluor Enterprises, a JV**OSM Departure Time:** 1900**Contractor:** Zhenhua Port Machinery Company, Ltd (ZPMC), Changxing Island **Location:** Shanghai, China**CWI Name:** Zhu Zhong Hai**CWI Present:** Yes No**Inspected CWI report:** Yes No N/A**Rod Oven in Use:** Yes No N/A**Electrode to specification:** Yes No N/A**Weld Procedures Followed:** Yes No N/A**Qualified Welders:** Yes No N/A**Verified Joint Fit-up:** Yes No N/A**Approved Drawings:** Yes No N/A**Approved WPS:** Yes No N/A**Delayed / Cancelled:** Yes No N/A**Bridge No:** 34-0006**Component:** Orthotropic Box Girder(OBG)**Summary of Items Observed:**

OBG # TRIAL ASSEMBLY YARD

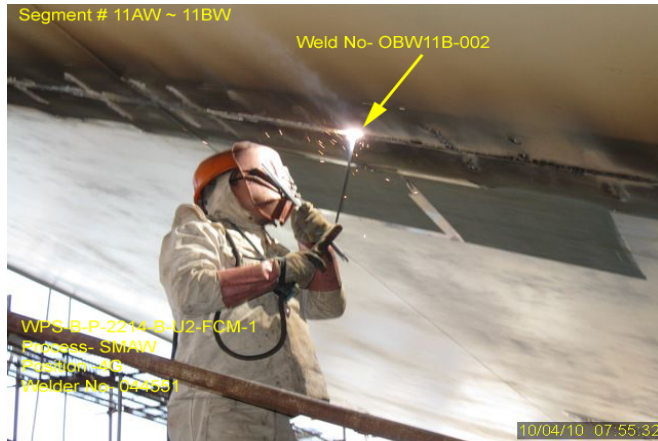
WELDING**Segment # 10CW**

This QA inspector observed ZPMC qualified welding personnel identified as 044551 perform Shielded Metal Arc Welding (SMAW), weld joint identified as OBW11B-002; located On Orthotropic Box Girder (OBG) Side Plate to Side Plate Transverse CJP Joint. ZPMC Quality Control (QC) is identified as Mr. Zhou Peng. The welding variables recorded by QC appeared to comply with the Applicable WPS-B-P-2214-B-U2-FCM-1. See the attached Photo
